TEMPERATURE AND PRESSURE PROFILES OBTAINED DURING BURN OF A SIDEWINDER MARK 17 MOD 5 MOTOR IN A 15,300 CUBIC-FOOT MAGAZINE

DL Technical Report No. TR-3139
September 1974

ABSTRACT

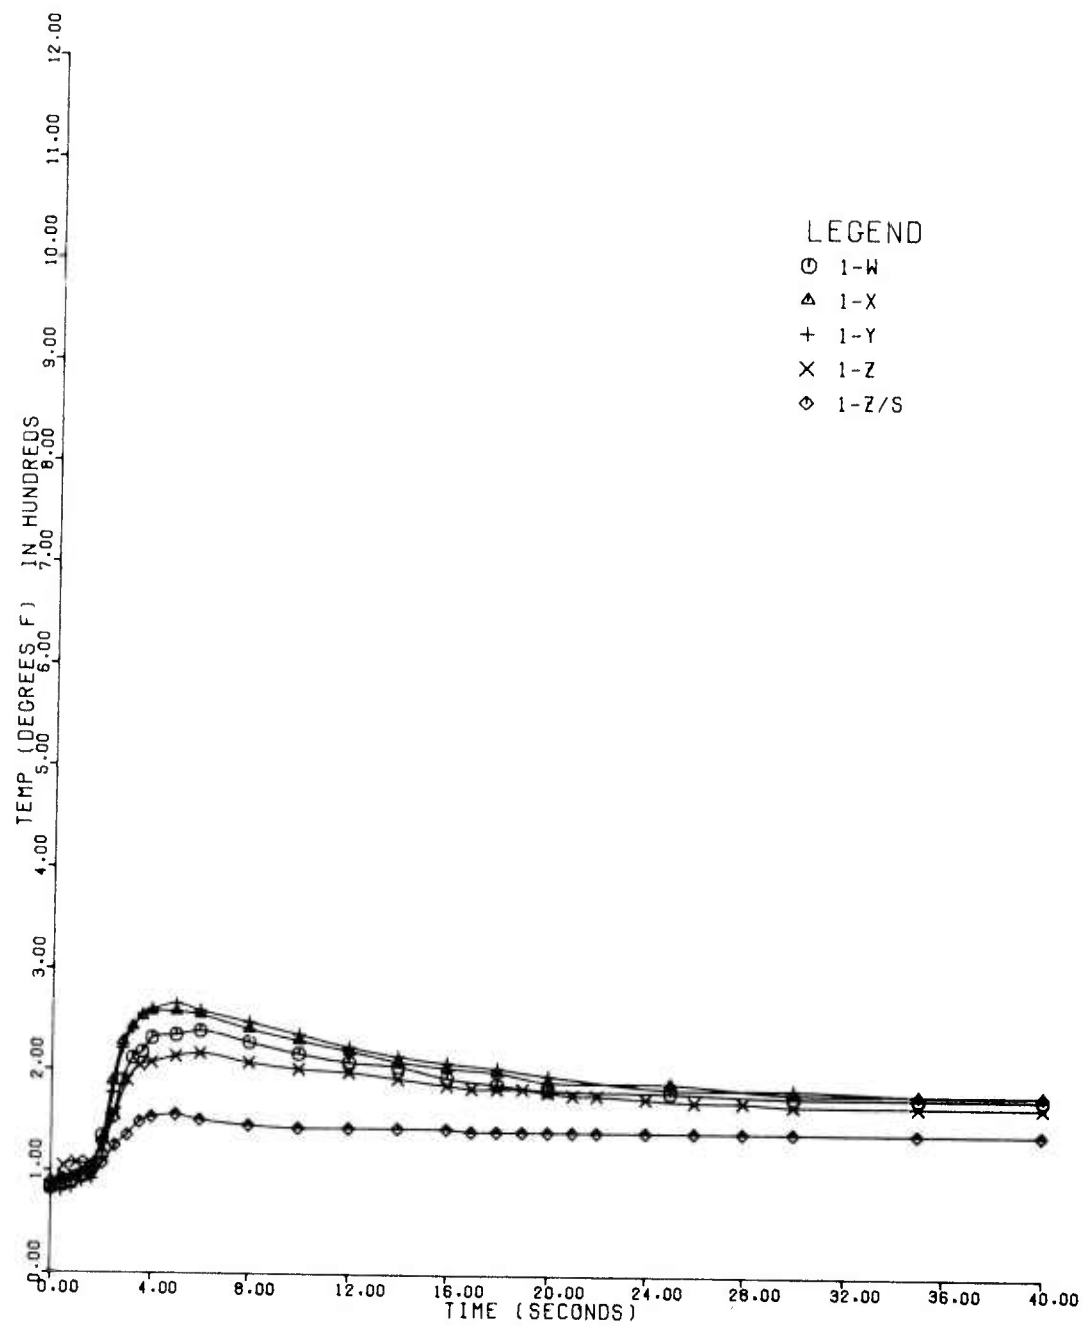
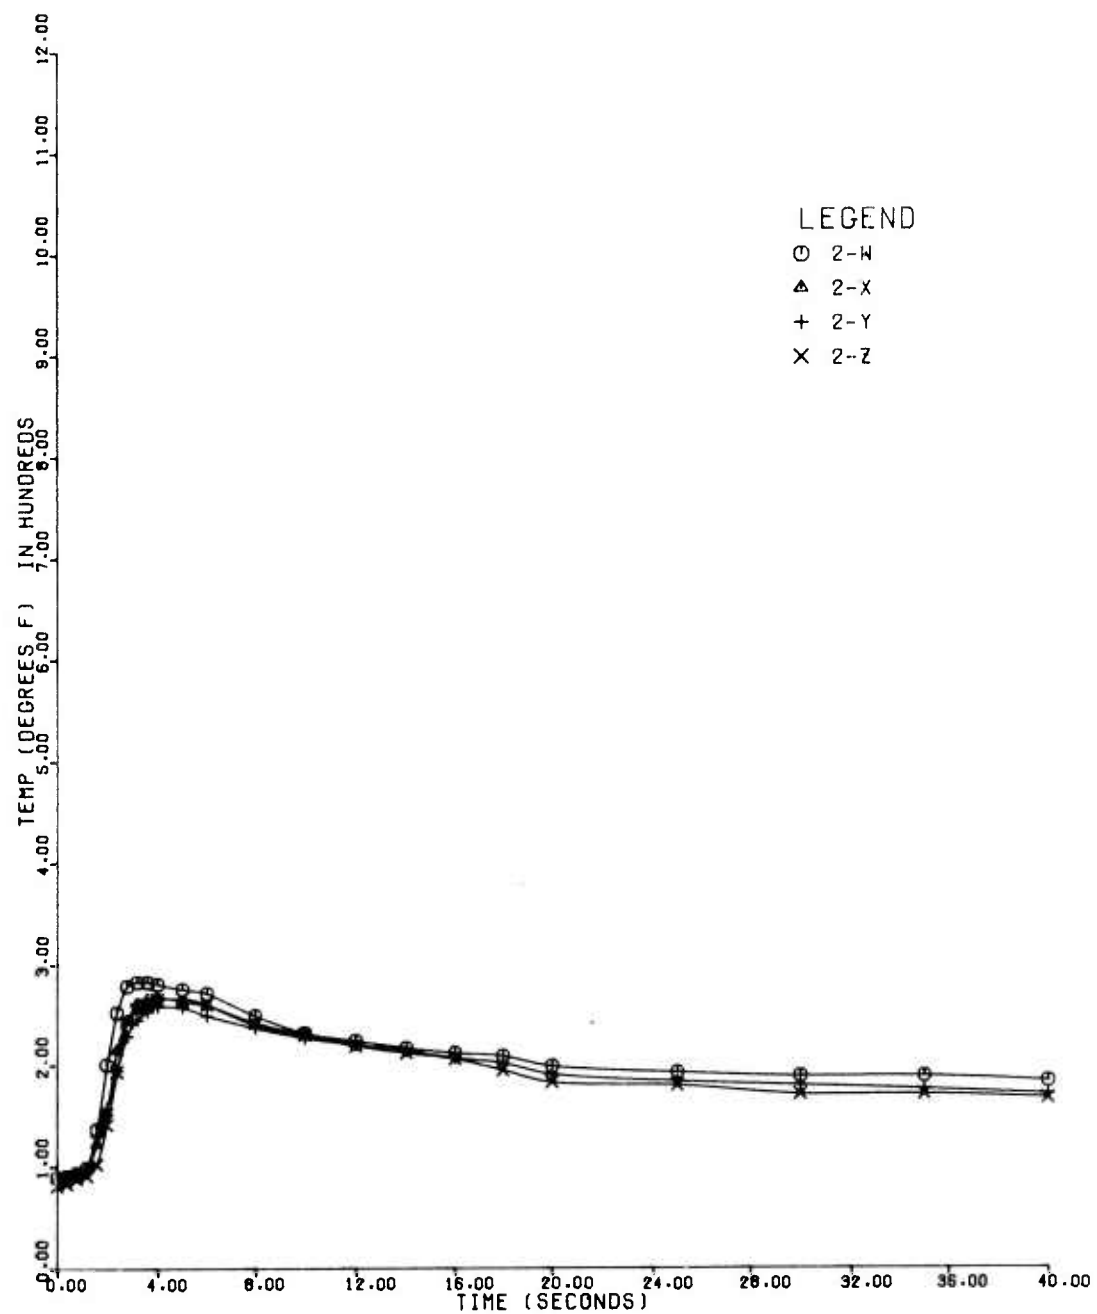
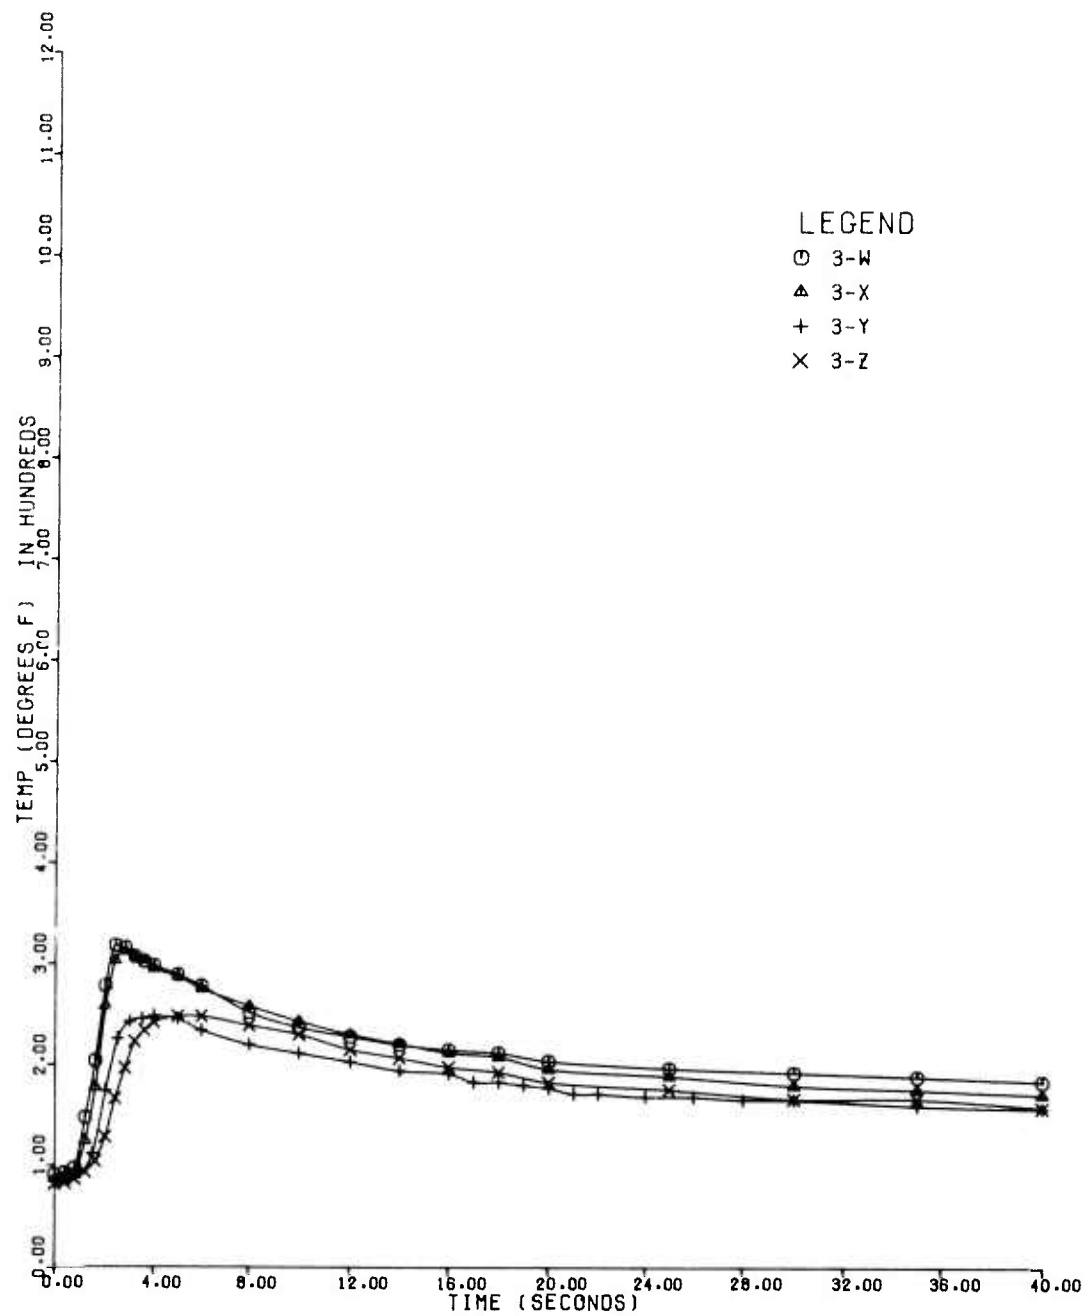
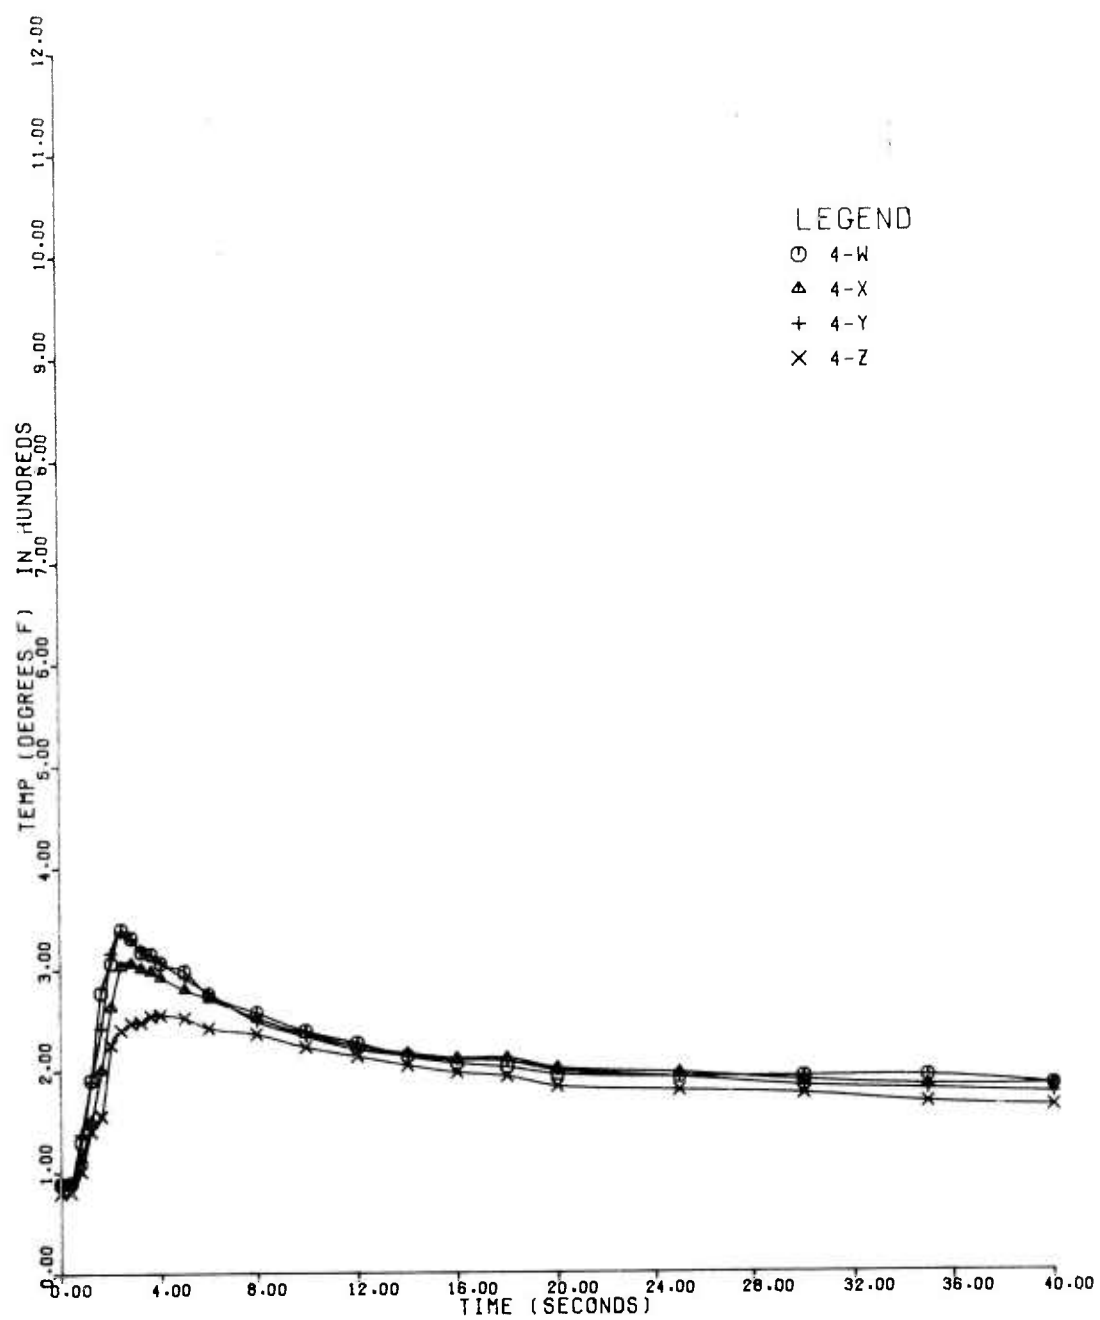
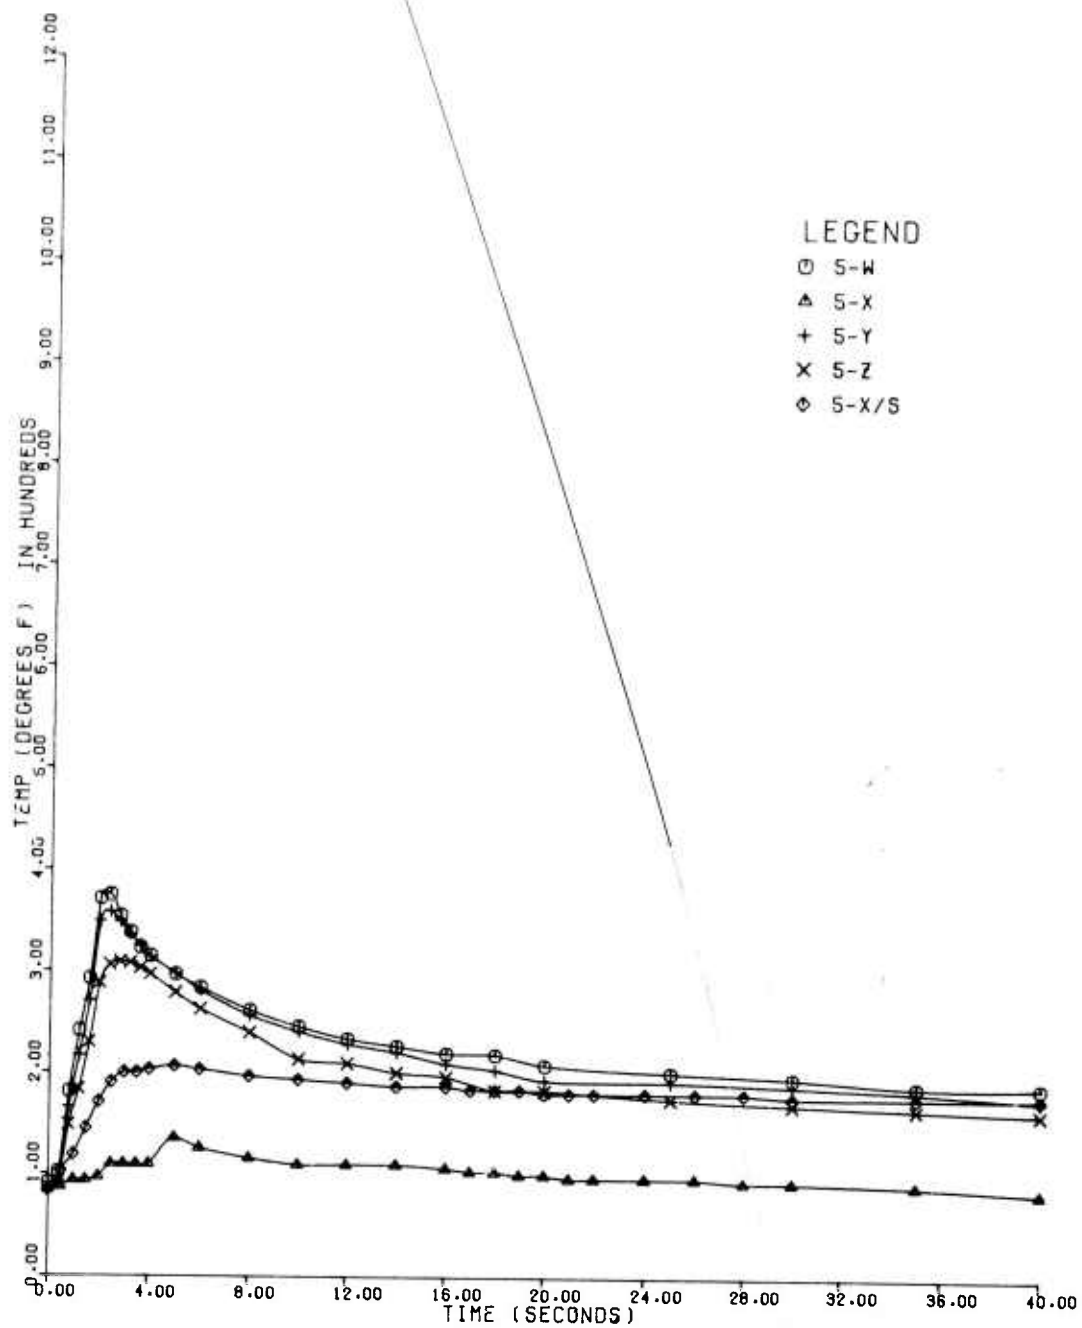
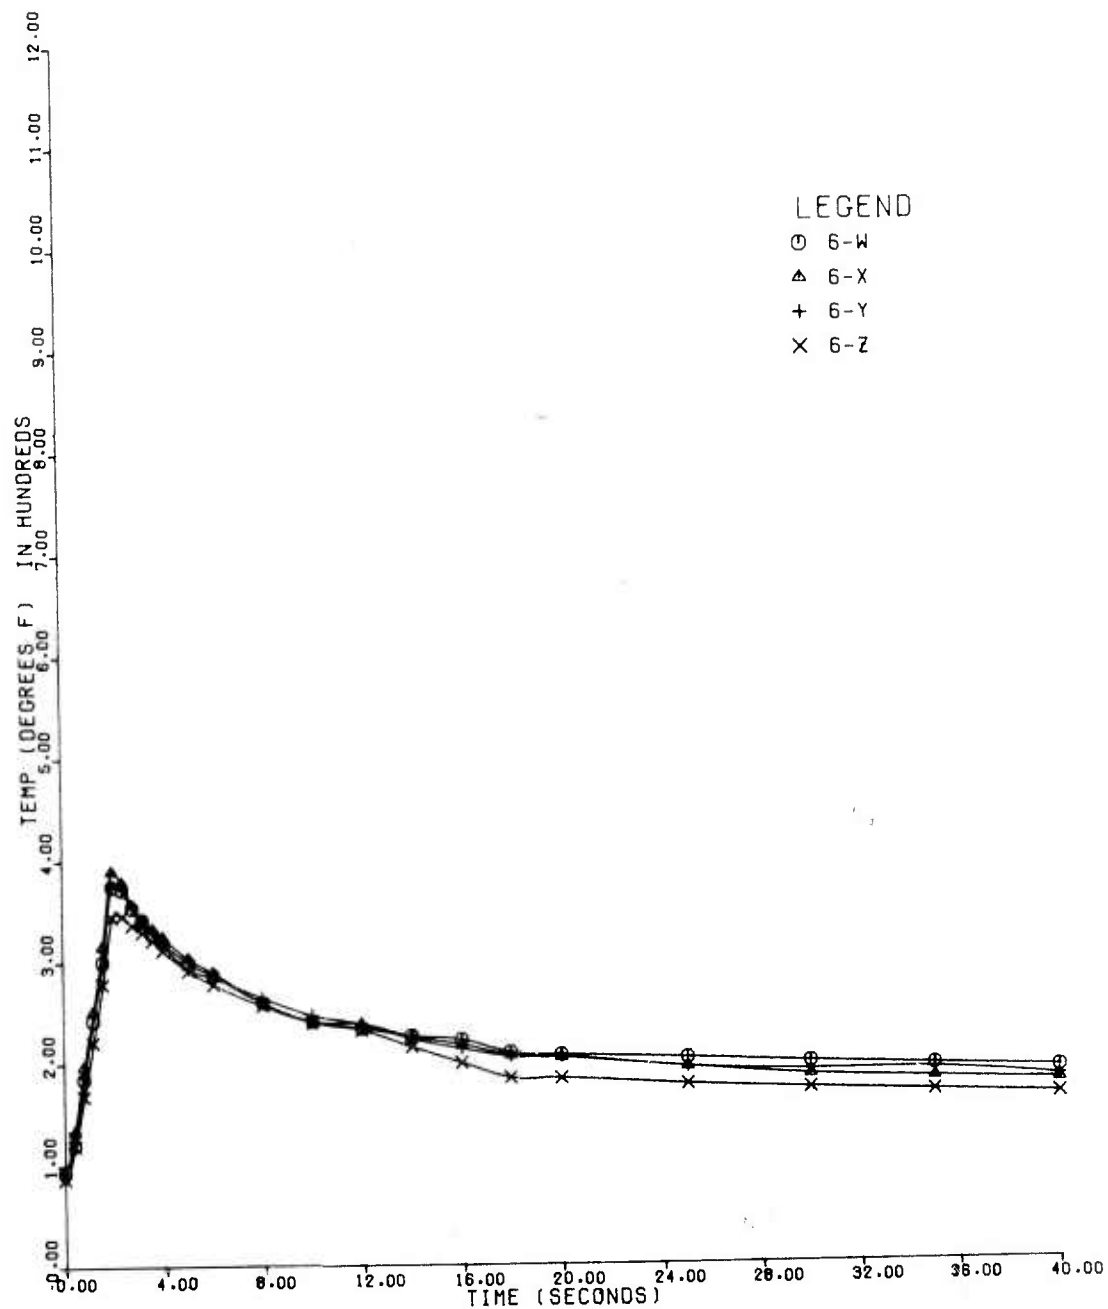
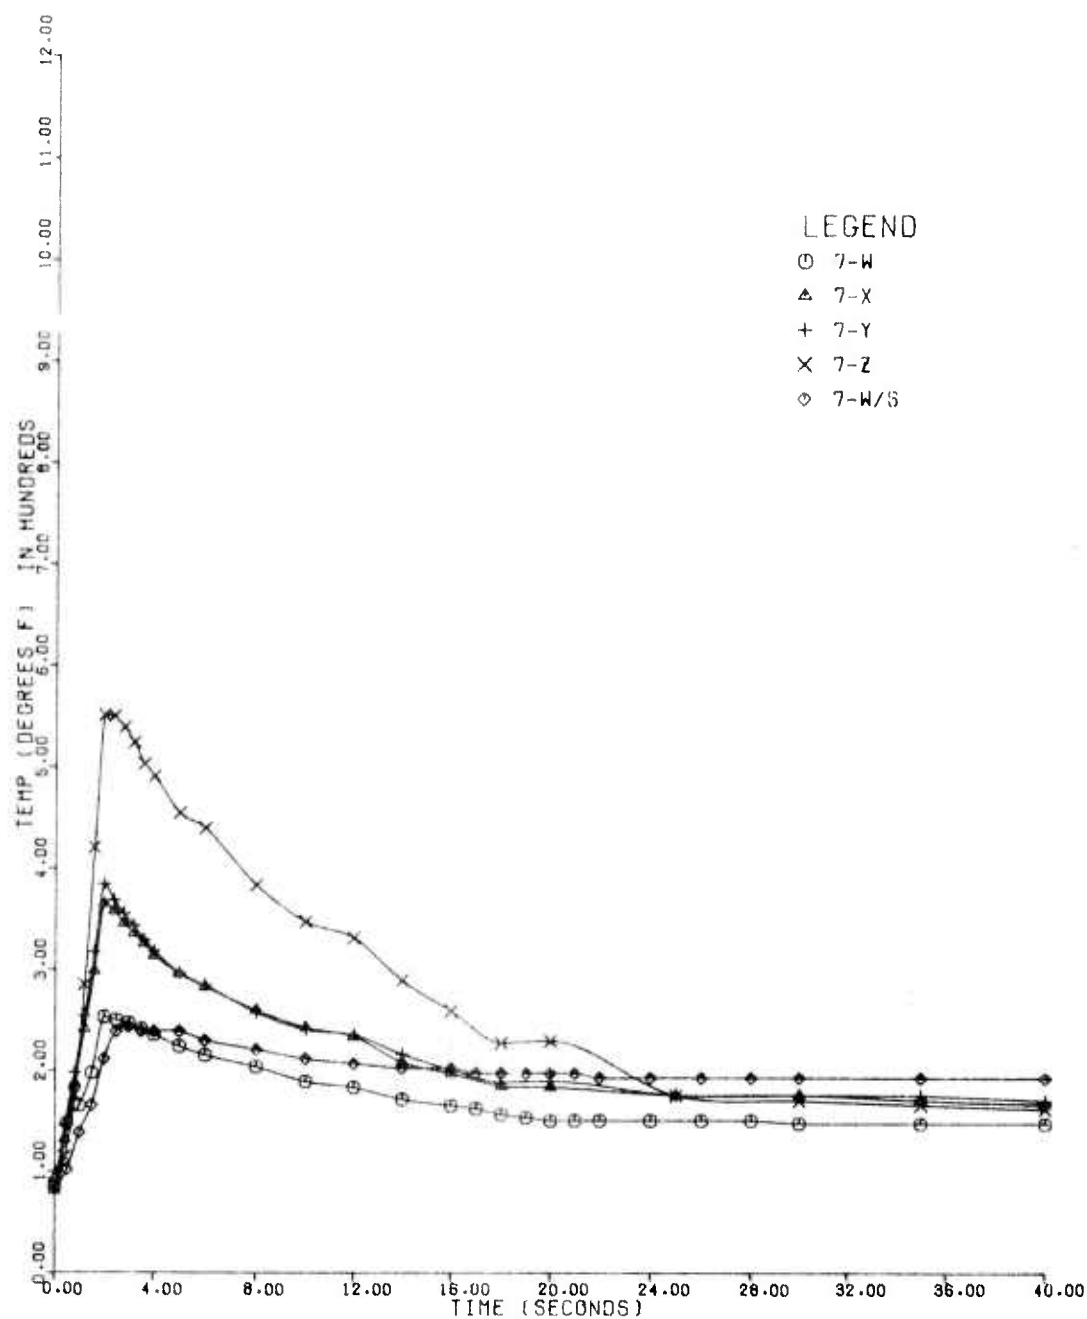
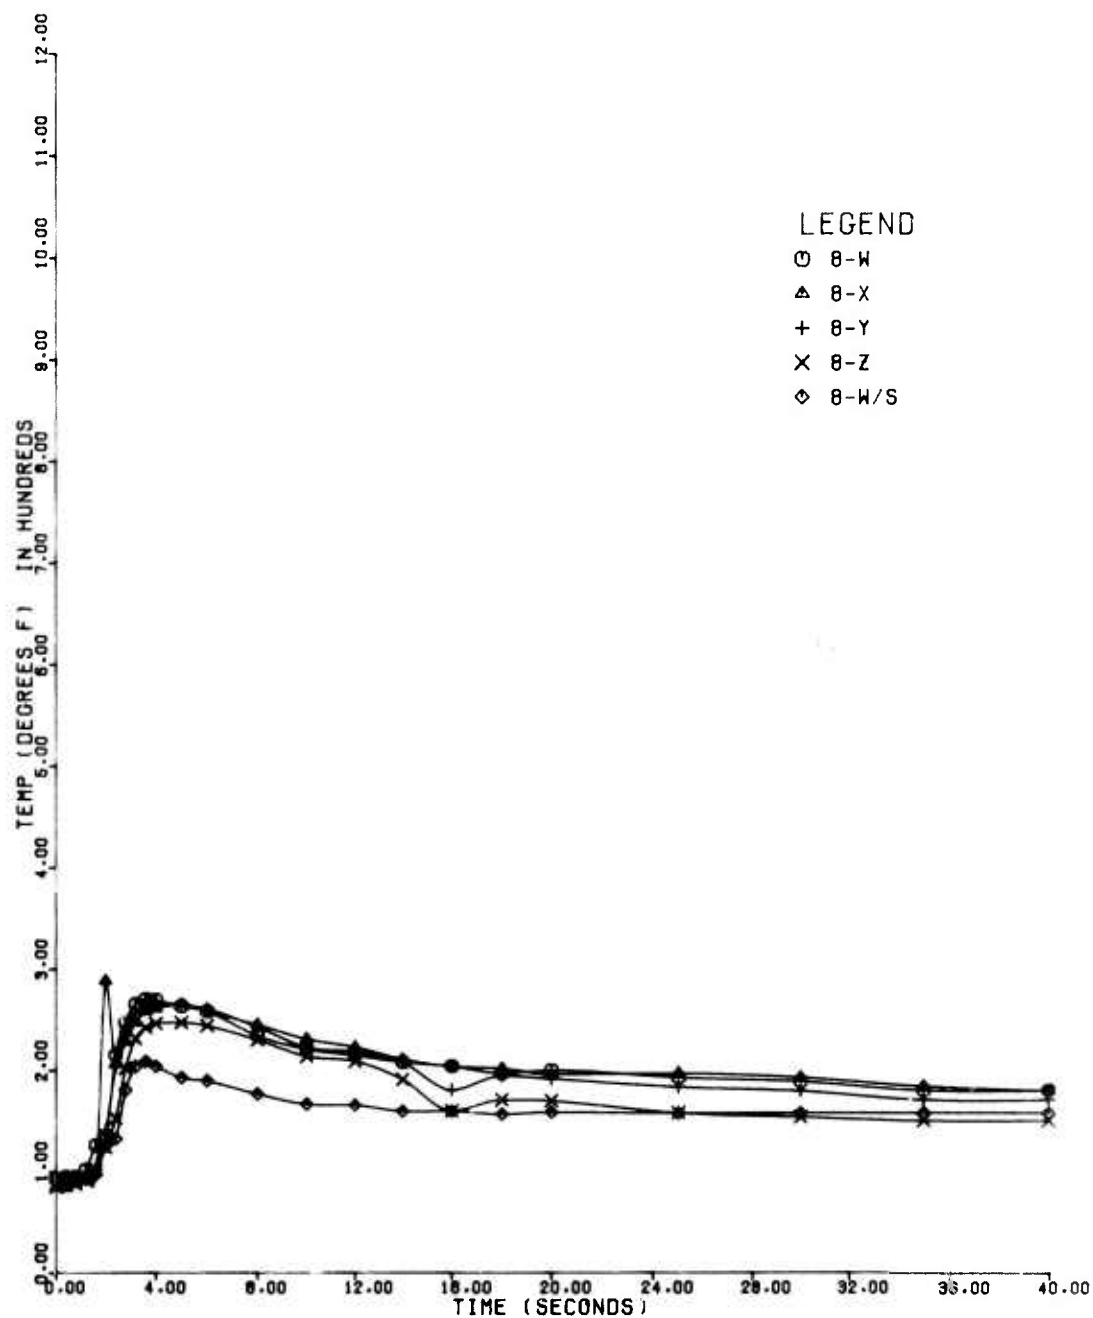
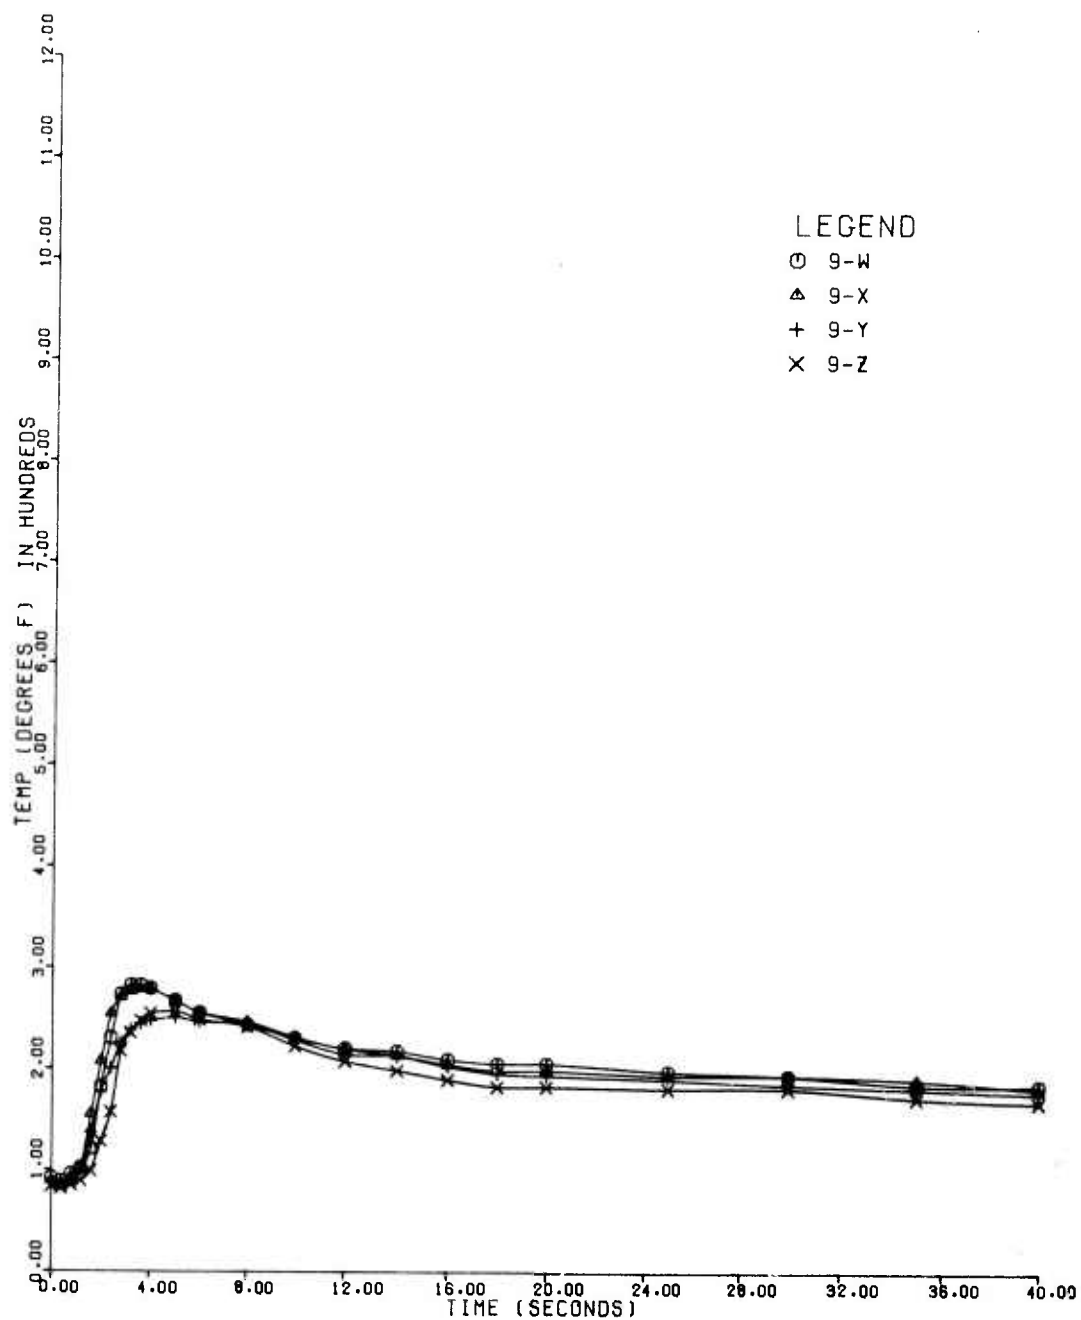
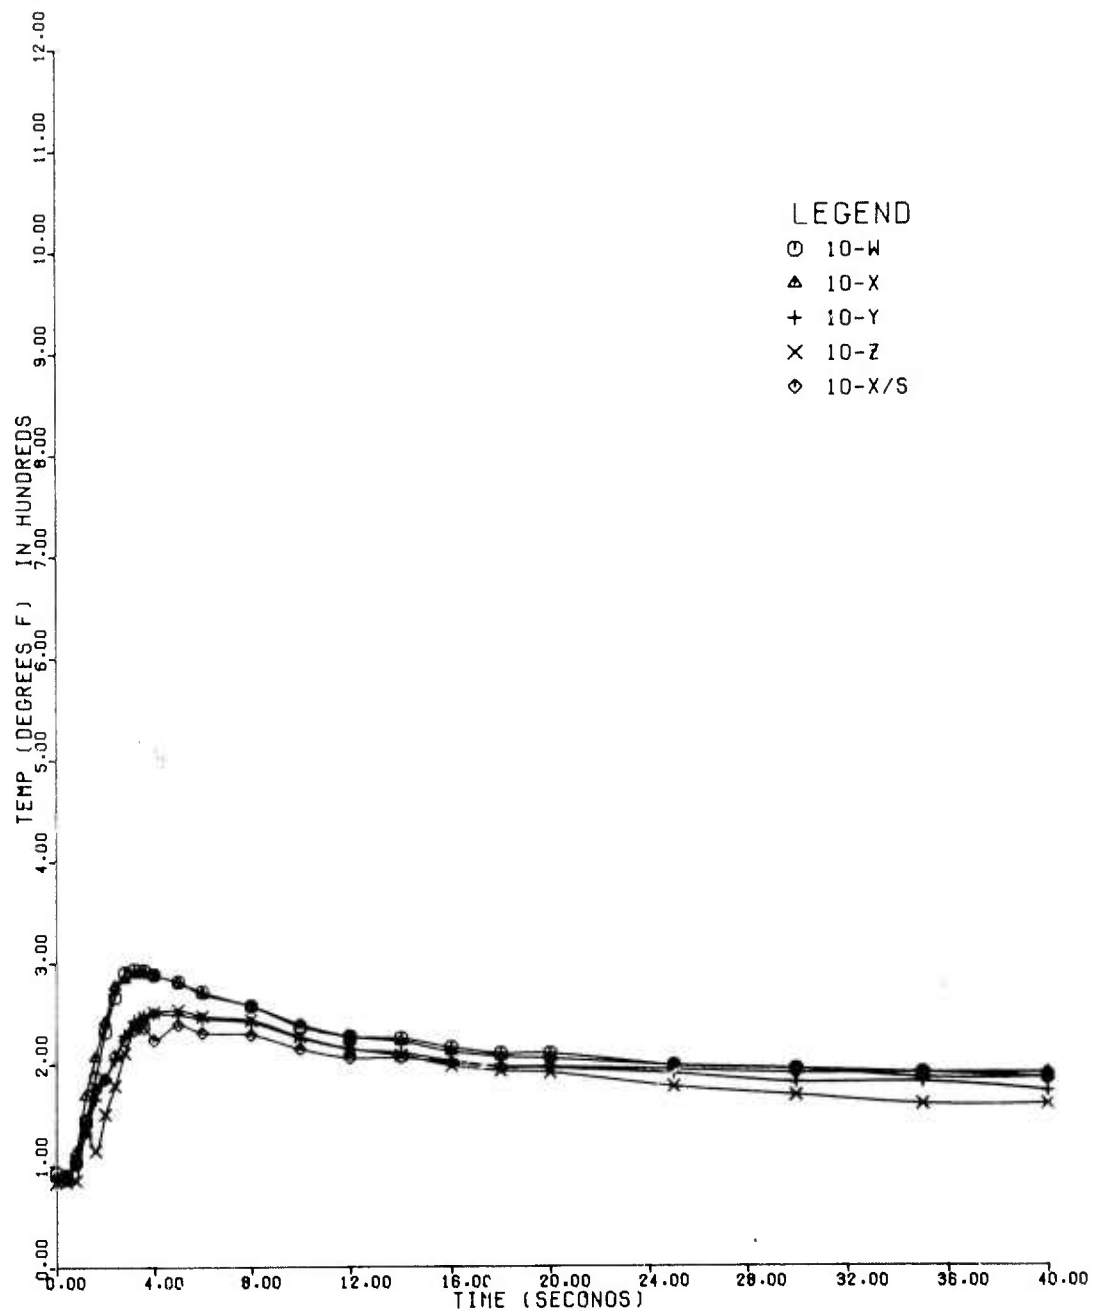
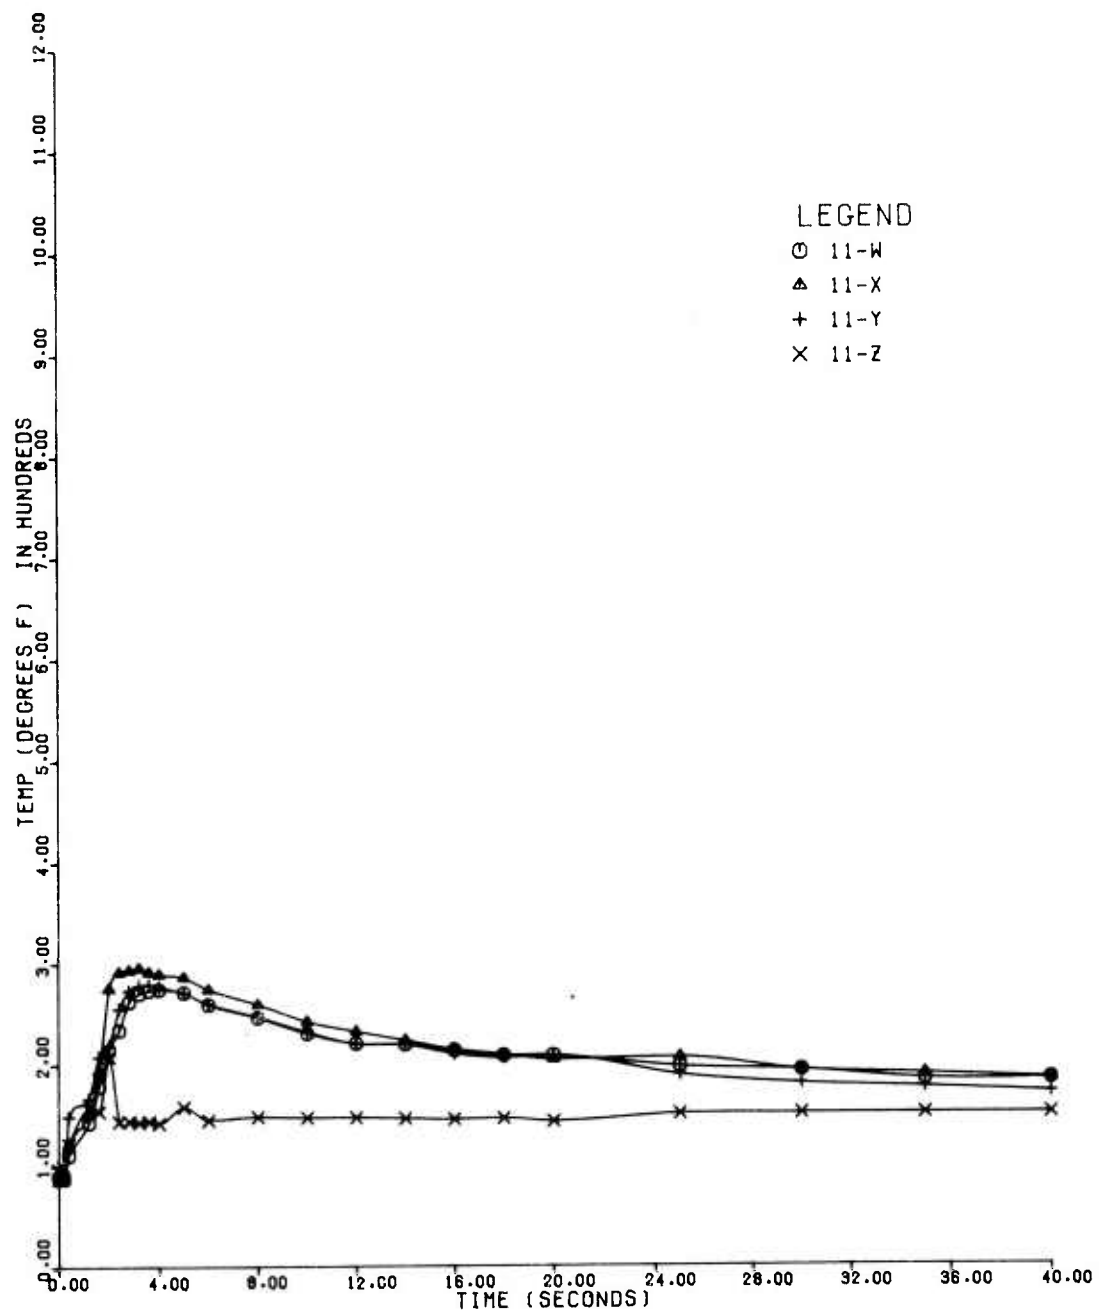
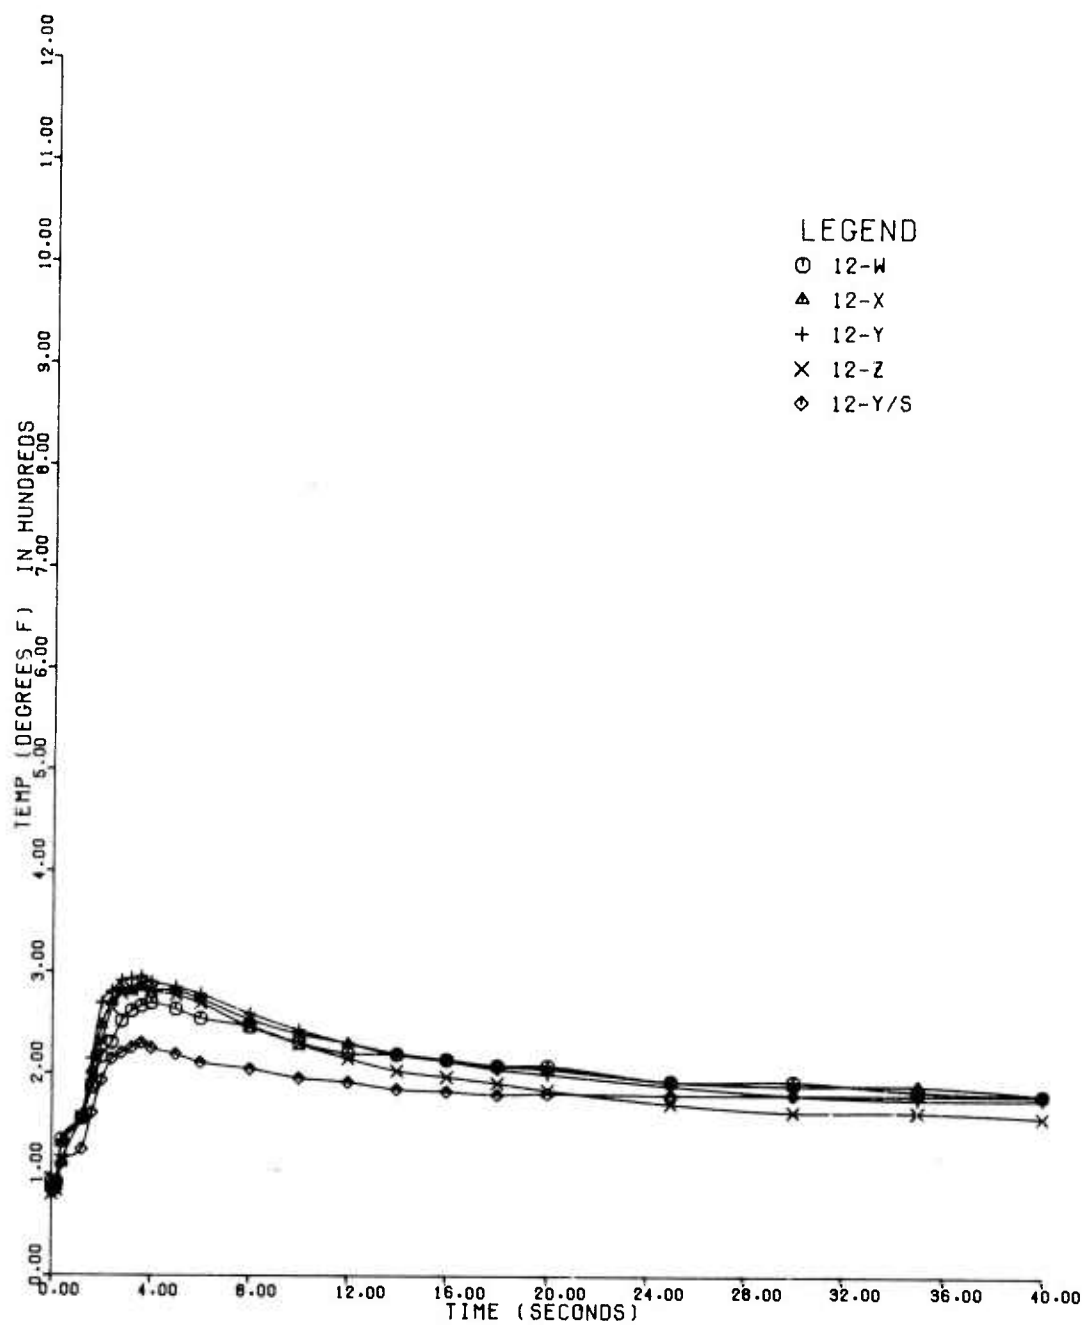
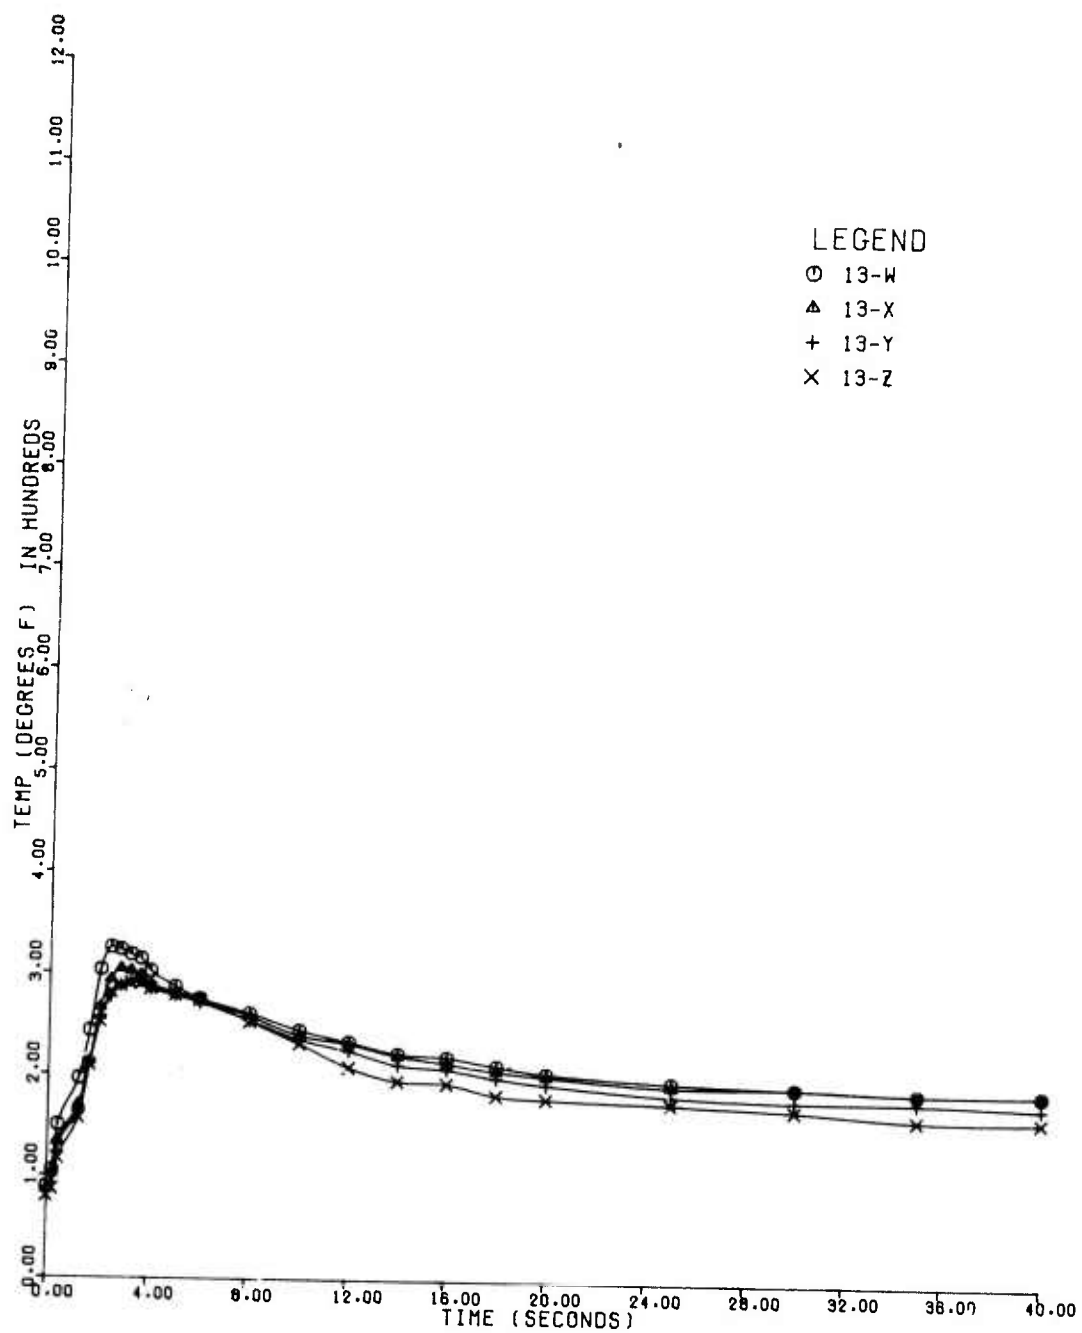
The detailed temperature/time, pressure/time, and related data, including photographs obtained during Tests Nos. 1 and 2 are presented in Appendices B through E. The temperature curves 8-x and 8-y shown in Figure 13 of Appendix B, 17-z in Figure 22, and 20-w in Figure 25 of Appendix E, recorded during Tests Nos. 1 and 2, respectively, show an erratic drop followed by a rise in the temperature pattern. These unusual temperature patterns may be due (in part) to erratic behavior of and/or failure of the individual thermocouples. The results of these tests are given below.

(3) A temperature profile of the magazine (interior) is shown in Figures 6 through 27 of Appendix B.

1. It is evident from the magazine thermal and pressure data (shown in Figures 6 through 27 in Appendices B, and E) obtained during burn of a SIDEWINDER MK 17 MOD 5 rocket motor in Tests Nos. 1 and 2, that the magazine thermal environment was not as severe as expected or desired. Because of these low temperature and pressure profiles, a SPARROW MK 38 motor was used as the active motor in follow-on tests.

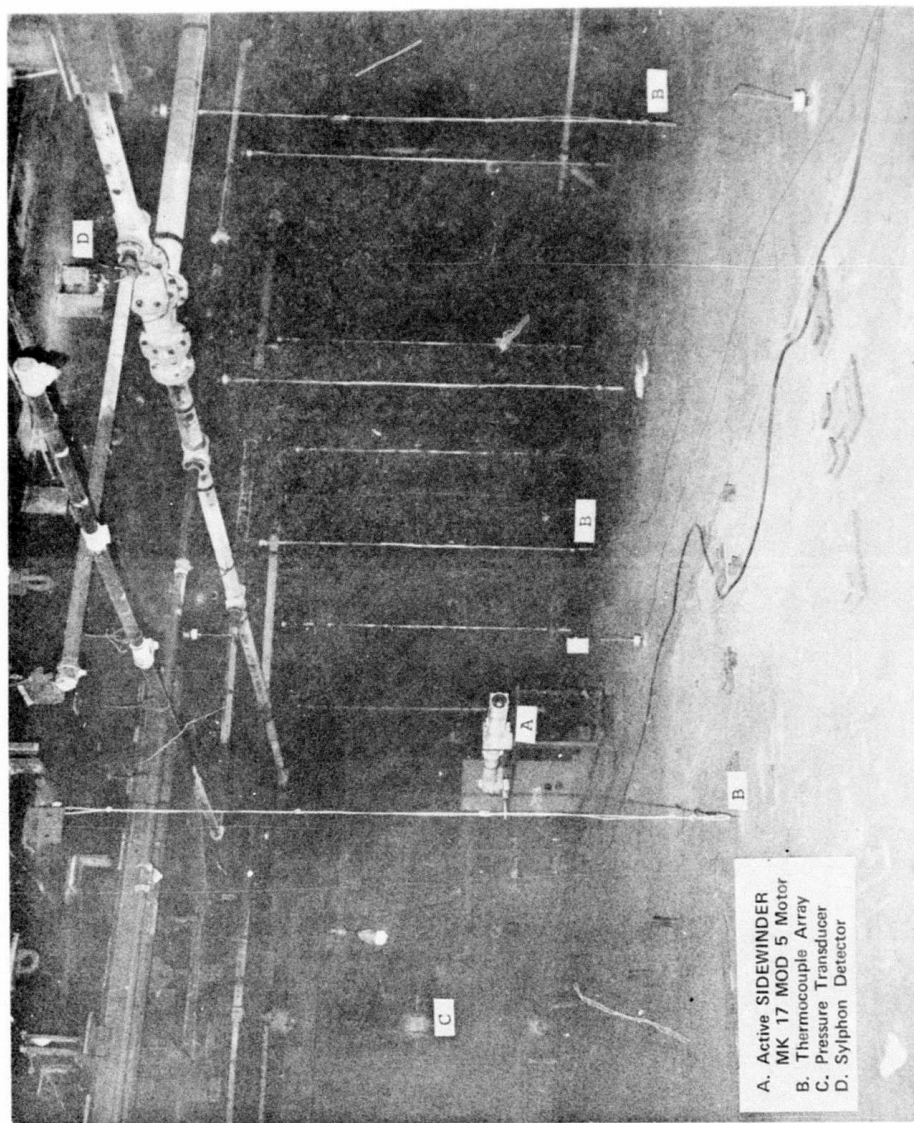
FIGURE D-1
Magazine Instrumentation Array and Ordnance Configuration
Test No. 1 24 July 1973

(7) Figure 1 of Appendix D is a photograph of the magazine instrumentation and ordnance configuration.

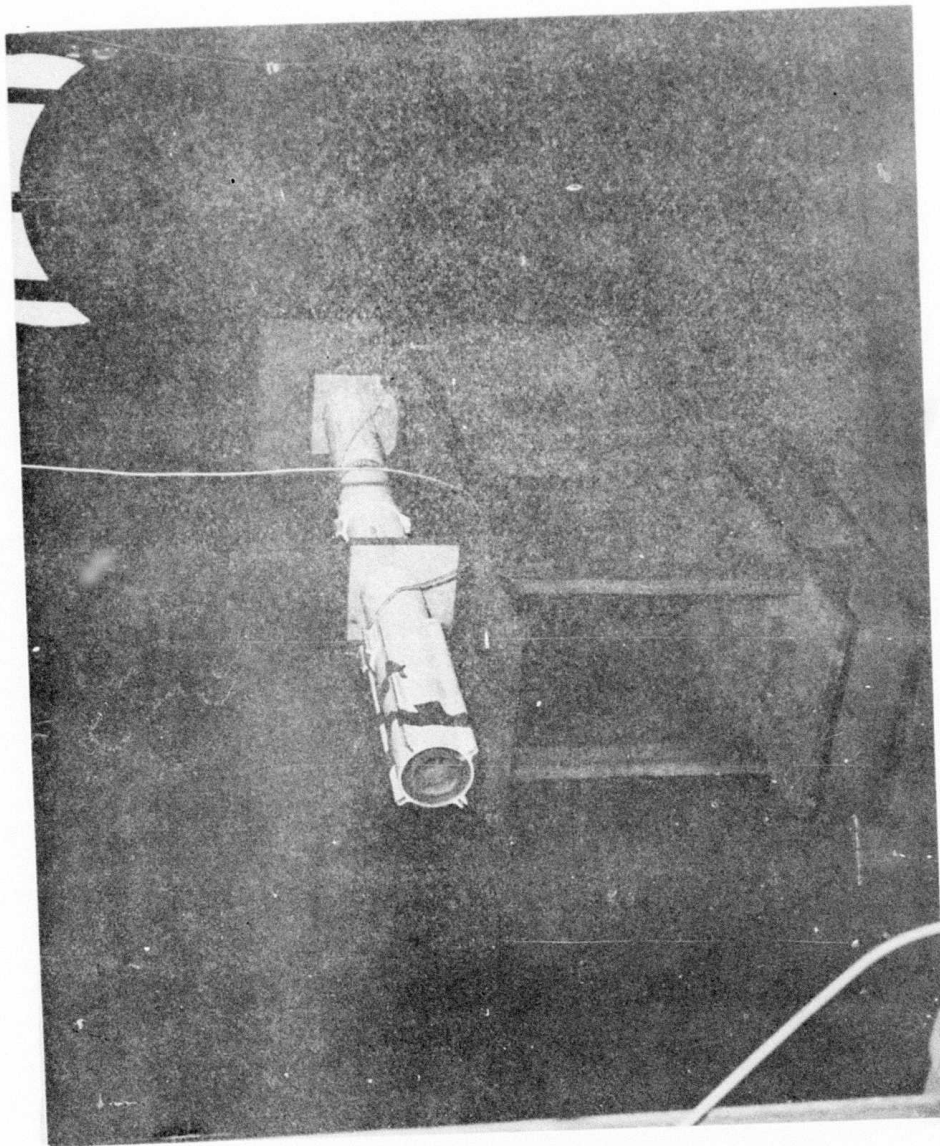
FIGURE D-2

(8) Figure 2 of Appendix D is a photograph of the active SIDEWINDER MK 17 MOD 5 motor mounted on the thrust stand.

Active SIDEWINDER MK 17 MOD 5 Motor Mounted on the Static Thrust Stand
Tests No. 1 and No. 2

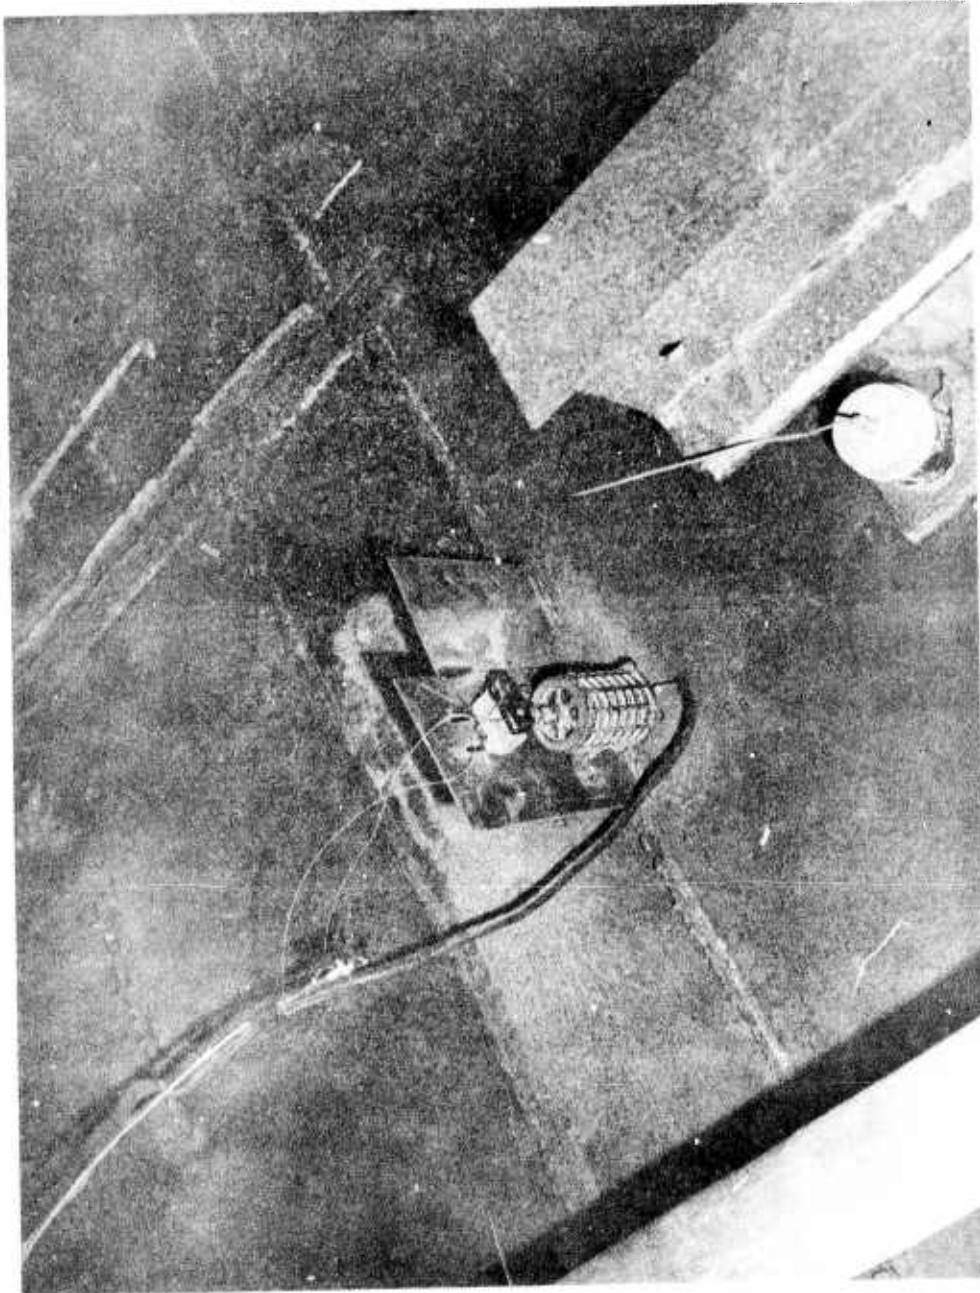
FIGURE D-3
Sylphon Detector and Microswitch Installation

(9) Figure 3 of Appendix D is a photograph of the Sylphon detector/microswitch installation.

(6) The metal slug in the Sylphon detector failed to melt.

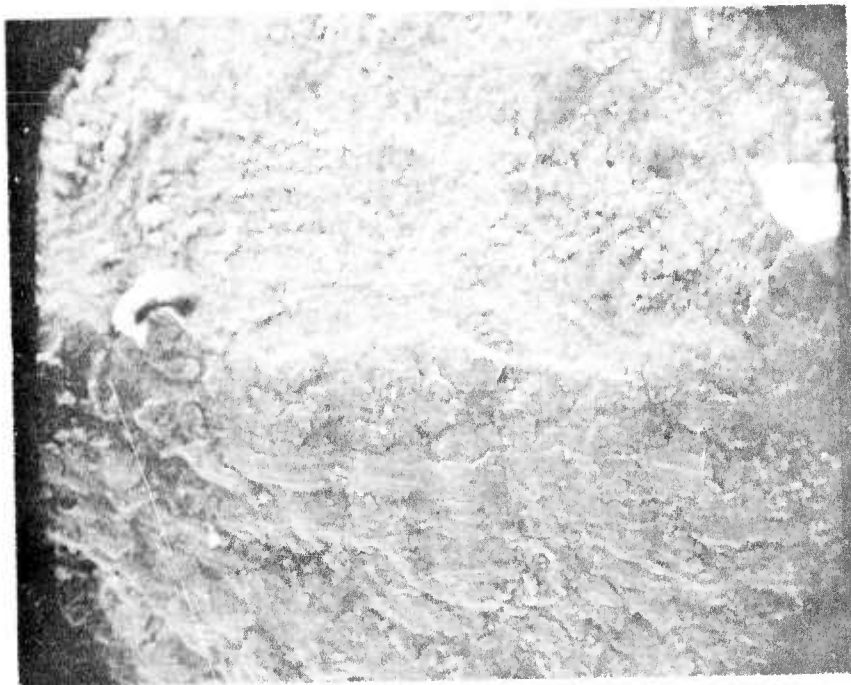
FIGURE D-4

(5) The magazine vented 1.7 seconds after motor ignition. Venting occurred through a 1.23-sq-ft opening. Failure of the blow-out patch shear-bolt (notched to release at 15 psig) resulted in premature magazine venting. Figure 4 of Appendix D (an electron microscope photograph of the recovered shear-bolt) shows the oxides (dark areas) formed in the stress fracture in the shear-bolt. The stress fracture occurred during the first test and the oxides were formed during the time interval between Test No. 1 and Test No. 2.

Electron Microscope Photograph of Ruptured Vent Shear-Bolt
Test No. 2 7 August 1973

3. In future tests, a 20" X 20" steel baffle will be mounted in front of the blow-out patch to prevent the dynamic pressure of the active motor exhaust from impinging on the blow-out patch.
